# A geospatial assessment of flood hazard in north-eastern depressed basin, Bangladesh

Floods are a frequently occurring calamity in deltaic Bangladesh. This paper aims to assess the temporal expansion of waterbodies during flooding using geospatial techniques. Several water indices were applied to classify the satellite images at various temporal scales. Among them, the Normalized Difference Water Index (NDWI) showed the highest correlation ( $r = 0.831$ ; where  $p = 0.01$ ) with rainfall data. Specifically, the NDWI results showed that perennial waterbodies measured 37 km<sup>2</sup> and 60 km<sup>2</sup> in Sunamganj District in 2017 and 2019, respectively. The area of waterbodies notably increased 52-fold from March to April (37 km<sup>2</sup> to 1958 km<sup>2</sup>) during the pre-monsoon flash flood of 2017. During the July 2019 monsoon flood, waterbodies started to extend after May and flooded 2784 km<sup>2</sup> in area. NDVI analysis showed that in 2019, floodwater submerged 361.7 km<sup>2</sup> of vegetation cover. At the same time, the Surma River's flooding resulted in a 73.9 per cent inundation of the total area of the Sunamganj District. We hope that this study will

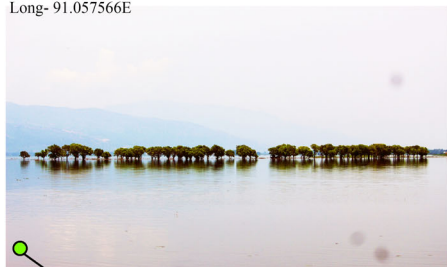
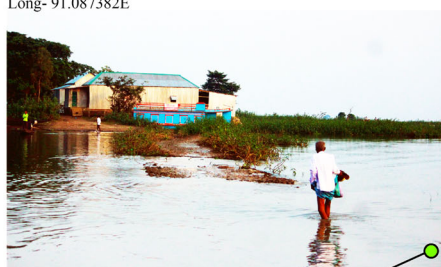
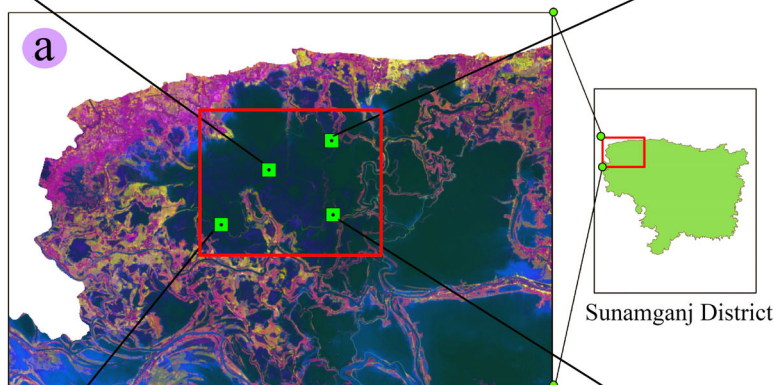
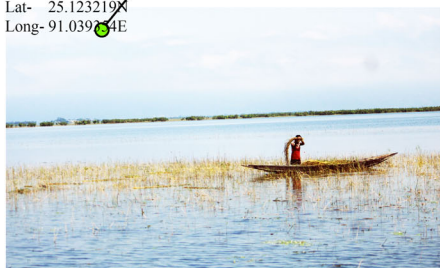
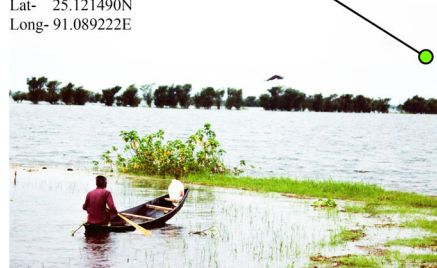
Figure 2 demonstrates water extension scenarios in the Tangua Haor area during the pre-monsoon season in 2018 (November 2018) and delineates the flooding in the Haor region in Sunamganj District. Image 01 shows (Hijol) trees partially submerged by the extension of perennial waters in the Haor region. Generally, this area is desiccated in the dry season. Farmers are used to cultivating several kinds of paddies over this area in the dry season. At the beginning of summer, the waterbodies started to extend, persisting till the late autumn season, flooding the areas depicted in Image 01. Image 02 shows people walking across the submerged roads to their homes. Seasonal flash floods regularly submerge several village roads. Image 03 shows a man collecting his cattle that graze on plants lying beneath the water. Image 04 reflects some

**Figure 2.** Photographs of flood conditions in the Haor region, Sunamganj District; (a) false-colour composition (FCC) of Haor region.

embankments that have been inundated by water, thereby forcing people to use boats as their vehicles. Excess rainfall creates surface runoff, and the surface runoff (from Meghalaya hill) causes the waters of the Surma River to swell, which then inundates the riparian zone, as explained below.

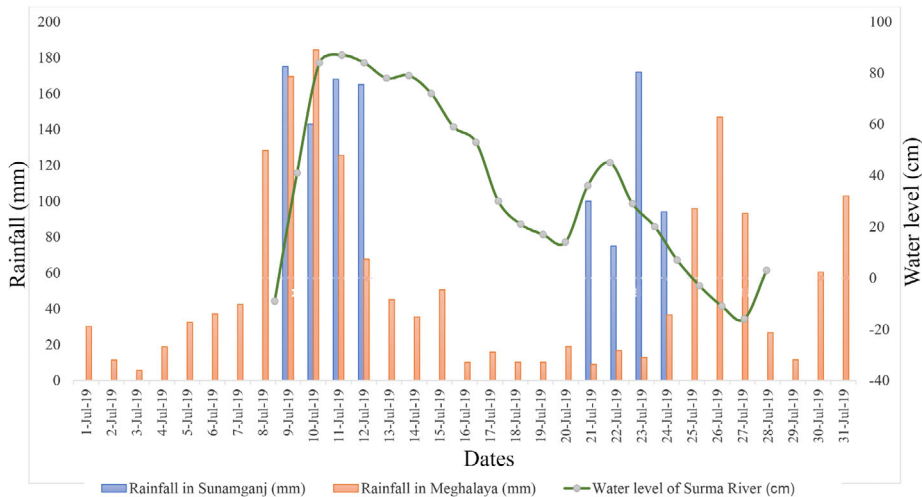
Figure 9. Amount of rainfall in the Sunamganj District and Meghalaya State (India), as well as the water level of Surma River during the flooding season in 2019. Source: Figure produced by authors.

Figure 9 shows that the water level of the Surma River increased because of excessive rainfall that occurred simultaneously in the Sunamganj District and the Meghalaya hilly catchment areas. Very heavy rainfall occurred from 8 July 2019 to 12 July 2019, which raised the water of the Surma River to dangerous levels. Subsequently though, the water level declined slowly over time. The water level of the Surma River rose to 84 cm causing severe flooding (inundating 73.9 per cent of the area) when it overflowed the riverbank in Sunamganj District. On 2 July 2019, the areas inundated in Sunamganj District totalled 2300.5 km<sup>2</sup> and extended up to 2784 km<sup>2</sup> on 17 July
